INFILTRATION RATES OF GREEN INFRASTRUCTURE CURB-CUT BASINS:
FINDING BALANCE BETWEEN FUNCTION AND AESTHETIC

A Thesis Submitted to the Faculty of the
DEPARTMENT HYDROLOGY AND ATMOSPHERIC SCIENCES

WITH A MAJOR IN HYDROLOGY

THE UNIVERSITY OF ARIZONA

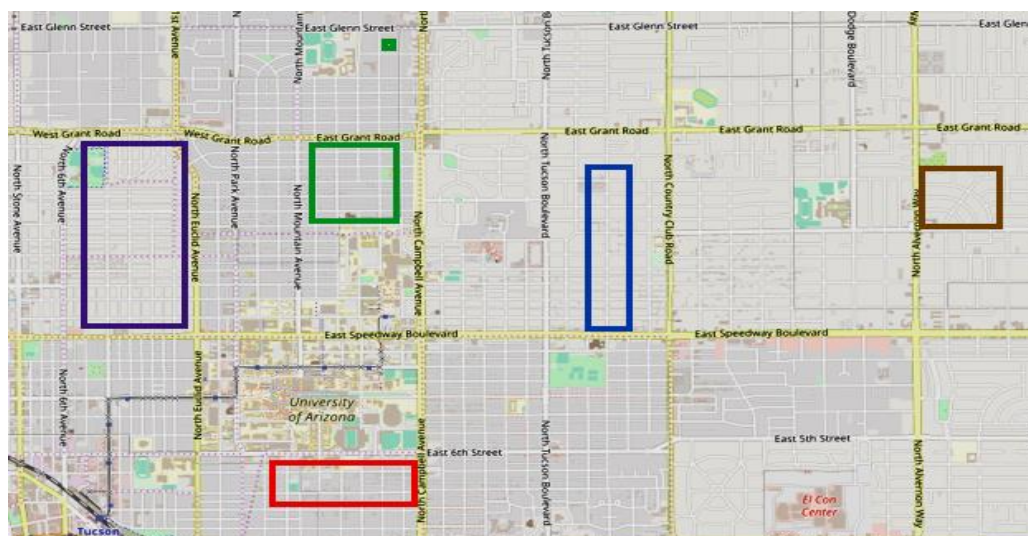
Figure 1 - Five neighborhoods of study in Tucson, Arizona: Feldman's (purple), Jefferson Park (green), Rincon Heights (red), Blenman Elm (blue), Garden District (brown).

This study was performed in five neighborhoods in Tucson, Arizona (Figure 1). Three neighborhoods are classified as National Register Historic Districts, and they are situated near parks and biking routes which encourage pedestrian travel. These neighborhoods were retrofitted with green infrastructure approximately six to eleven years ago. One neighborhood had a mix of basins projects, ranging from four to ten years in age. The fifth neighborhood had twelve curb-cuts installed in the spring of 2018 and provides a contrast to the older basins. The GI basins were placed in neighborhoods with the purpose of reducing stormwater flooding, providing urban tree canopy, and improving walkability. A total of 88 basins were measured, with a sample of 12 to 22 curb-cut basins from each neighborhood. The location of each basin measured in this study is seen in Figure 2.

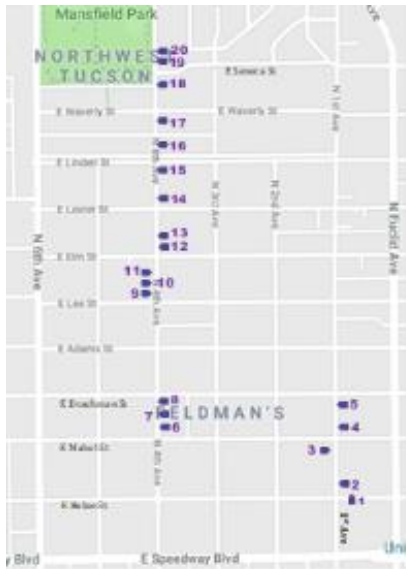
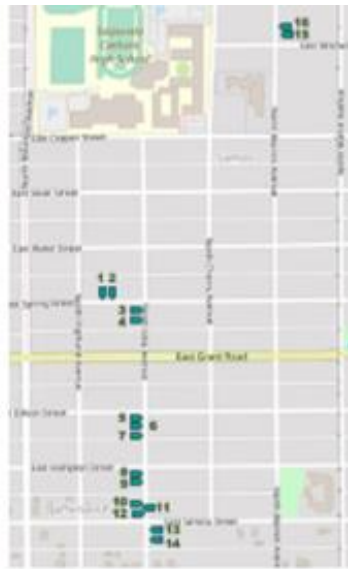
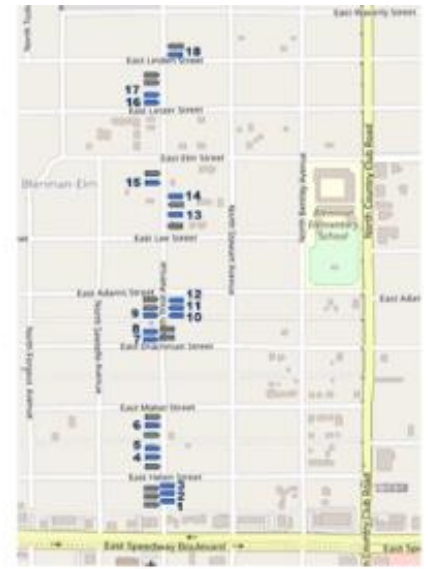
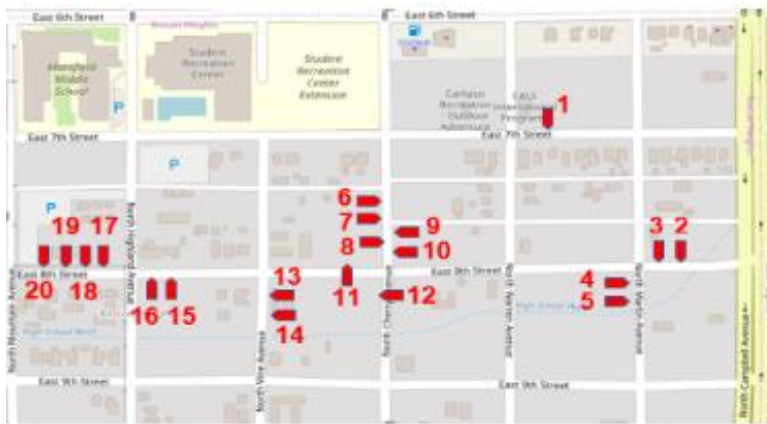
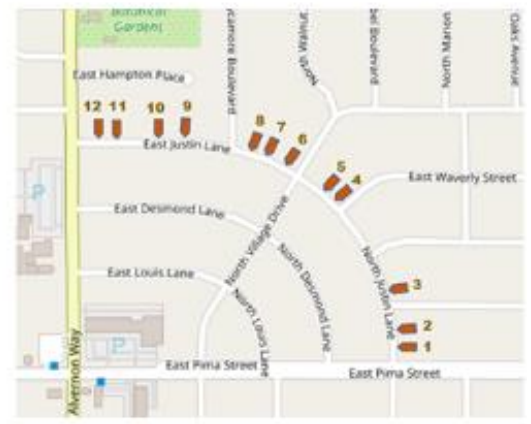
Figure 2 - (a-e). GI curb-cut basin locations in each neighborhood. Feldman's (a) with 22 basins. Jefferson Park (b) with 16 basins. Blenman Elm (c) with 18 basins. Rincon Heights (d) with 20 basins. Garden District with 12 basins (e).

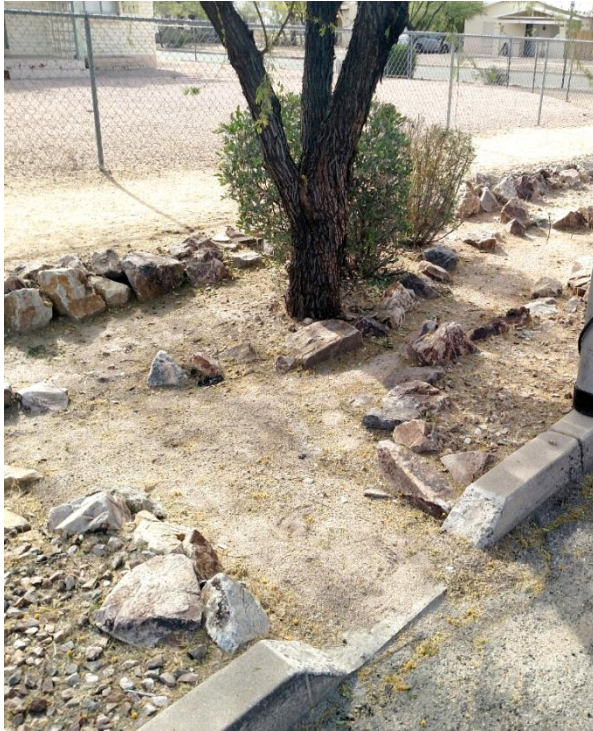
Figure 7 – Basin in great condition, Appears well-maintained.

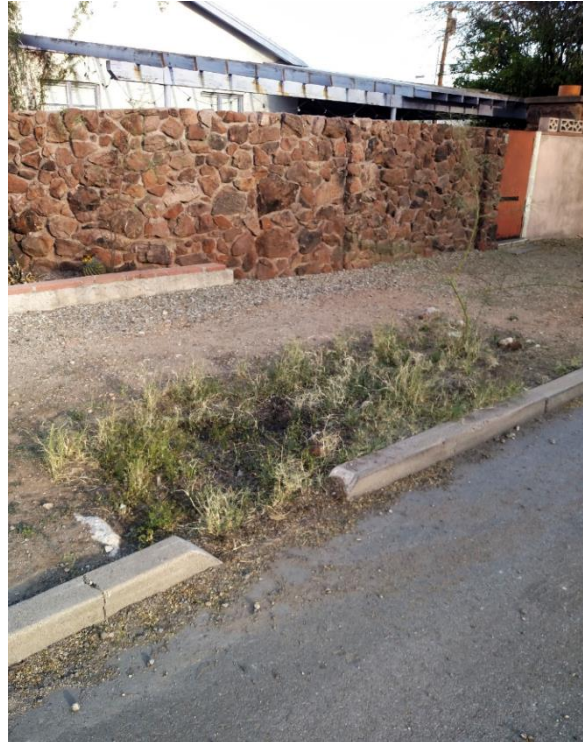
Figure 4 – Basin in poor condition, Appears neglected.
